VanVliet Lake Report

VILAS COUNTY, WISCONSIN

Summary of the Lake Management Study

Report: Summer 2005

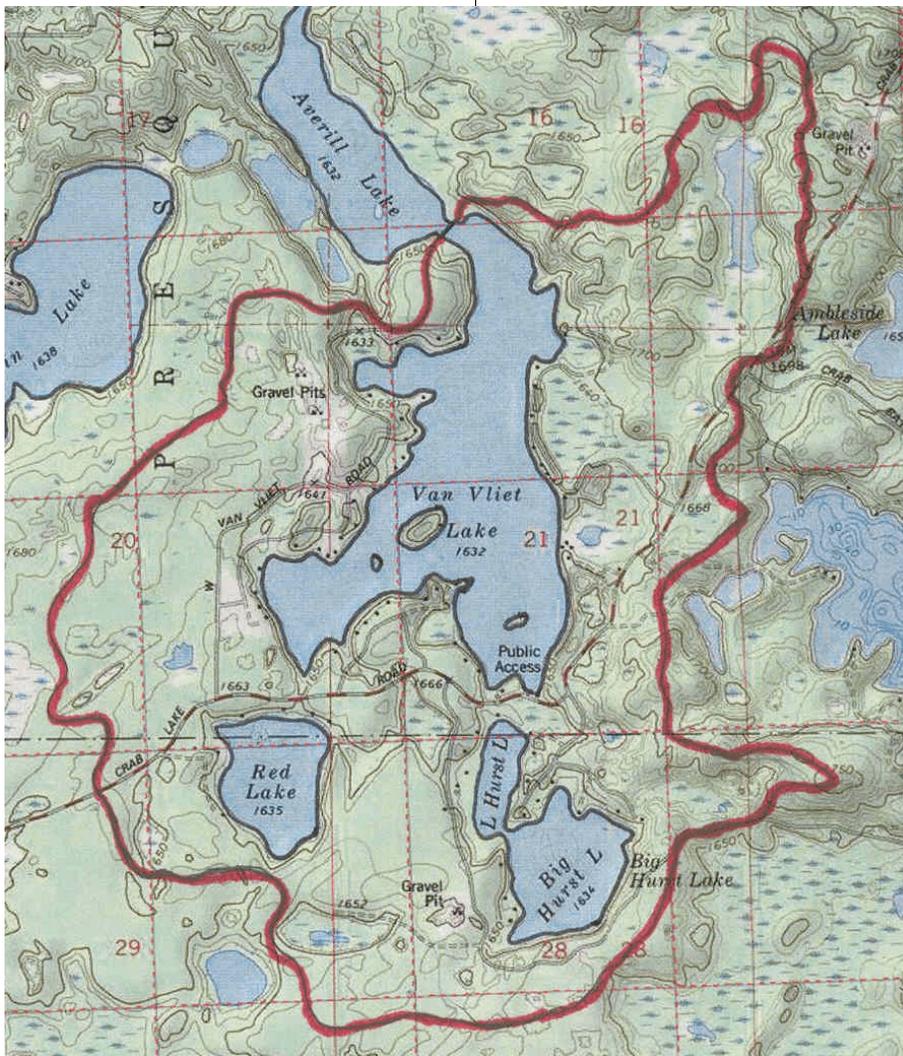
The watershed drainage area to VanVliet Lake is about 1,370 acres and is outlined in red.

The watershed area draining to VanVliet (not including the lake) is 1,370 acres. Land use is primarily forests and wetlands, with residential use accounting for a small percent of the total watershed area.

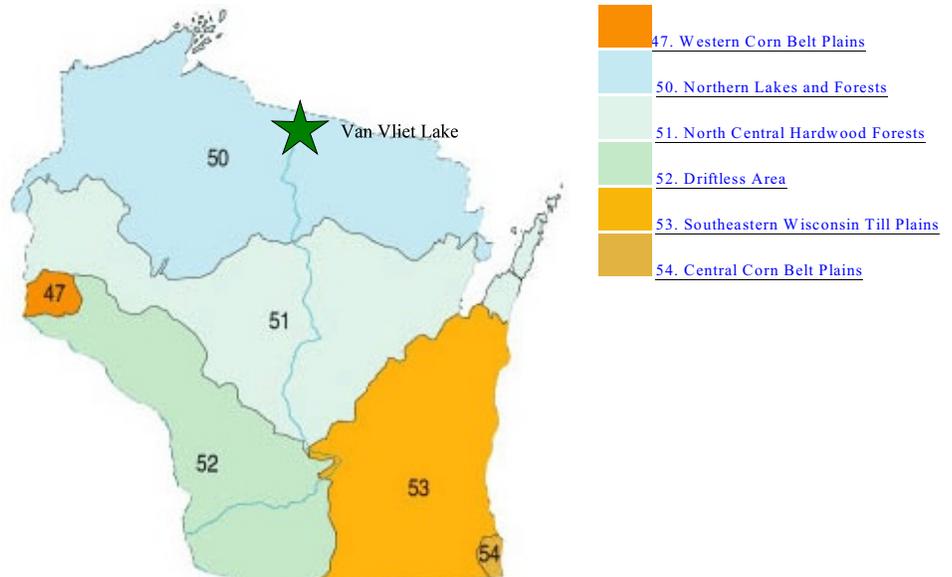
Ecoregions of Wisconsin

VanVliet Lake is located in the Northern Lakes and Forest Ecoregion. Lakes in this ecoregion have some of the best water quality in the state.

Phosphorus concentrations in VanVliet Lake are better than predicted when compared to other lakes in the Northern Lakes and Forest ecoregion. A growing season phosphorus average for 2004 for VanVliet Lake is 18 ppb. A predicted phosphorus concentration using ecoregion values is higher at about 24 ppb.

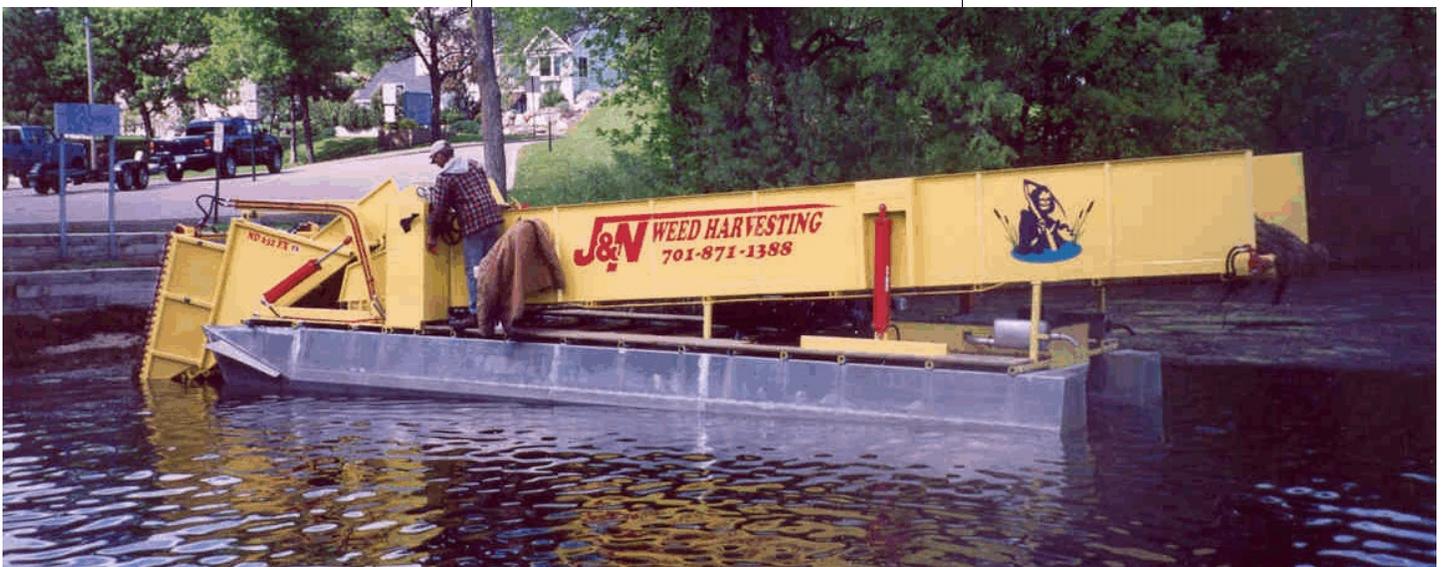
A mechanical harvester could be used to create cruising lanes through several areas of dense growth in VanVliet Lake.

If plant management is considered, a mechanical harvester is recommended because it will pick up the plant material. However, because of the soft sediment, there will be some sediment resuspension and a turbid condition will persist for a few days after harvesting is completed.

Along the western shore of VanVliet broadleaf pondweed, a desirable aquatic plant can grow to the surface. A mechanical harvester could be contracted to create navigational channels to allow boat passage.
